# Walk Around

## Focke-Wulf Fw 190A/F

Walk Around Number 22  
squadron/signal publications

By Malcolm Laing and E. Brown Ryle

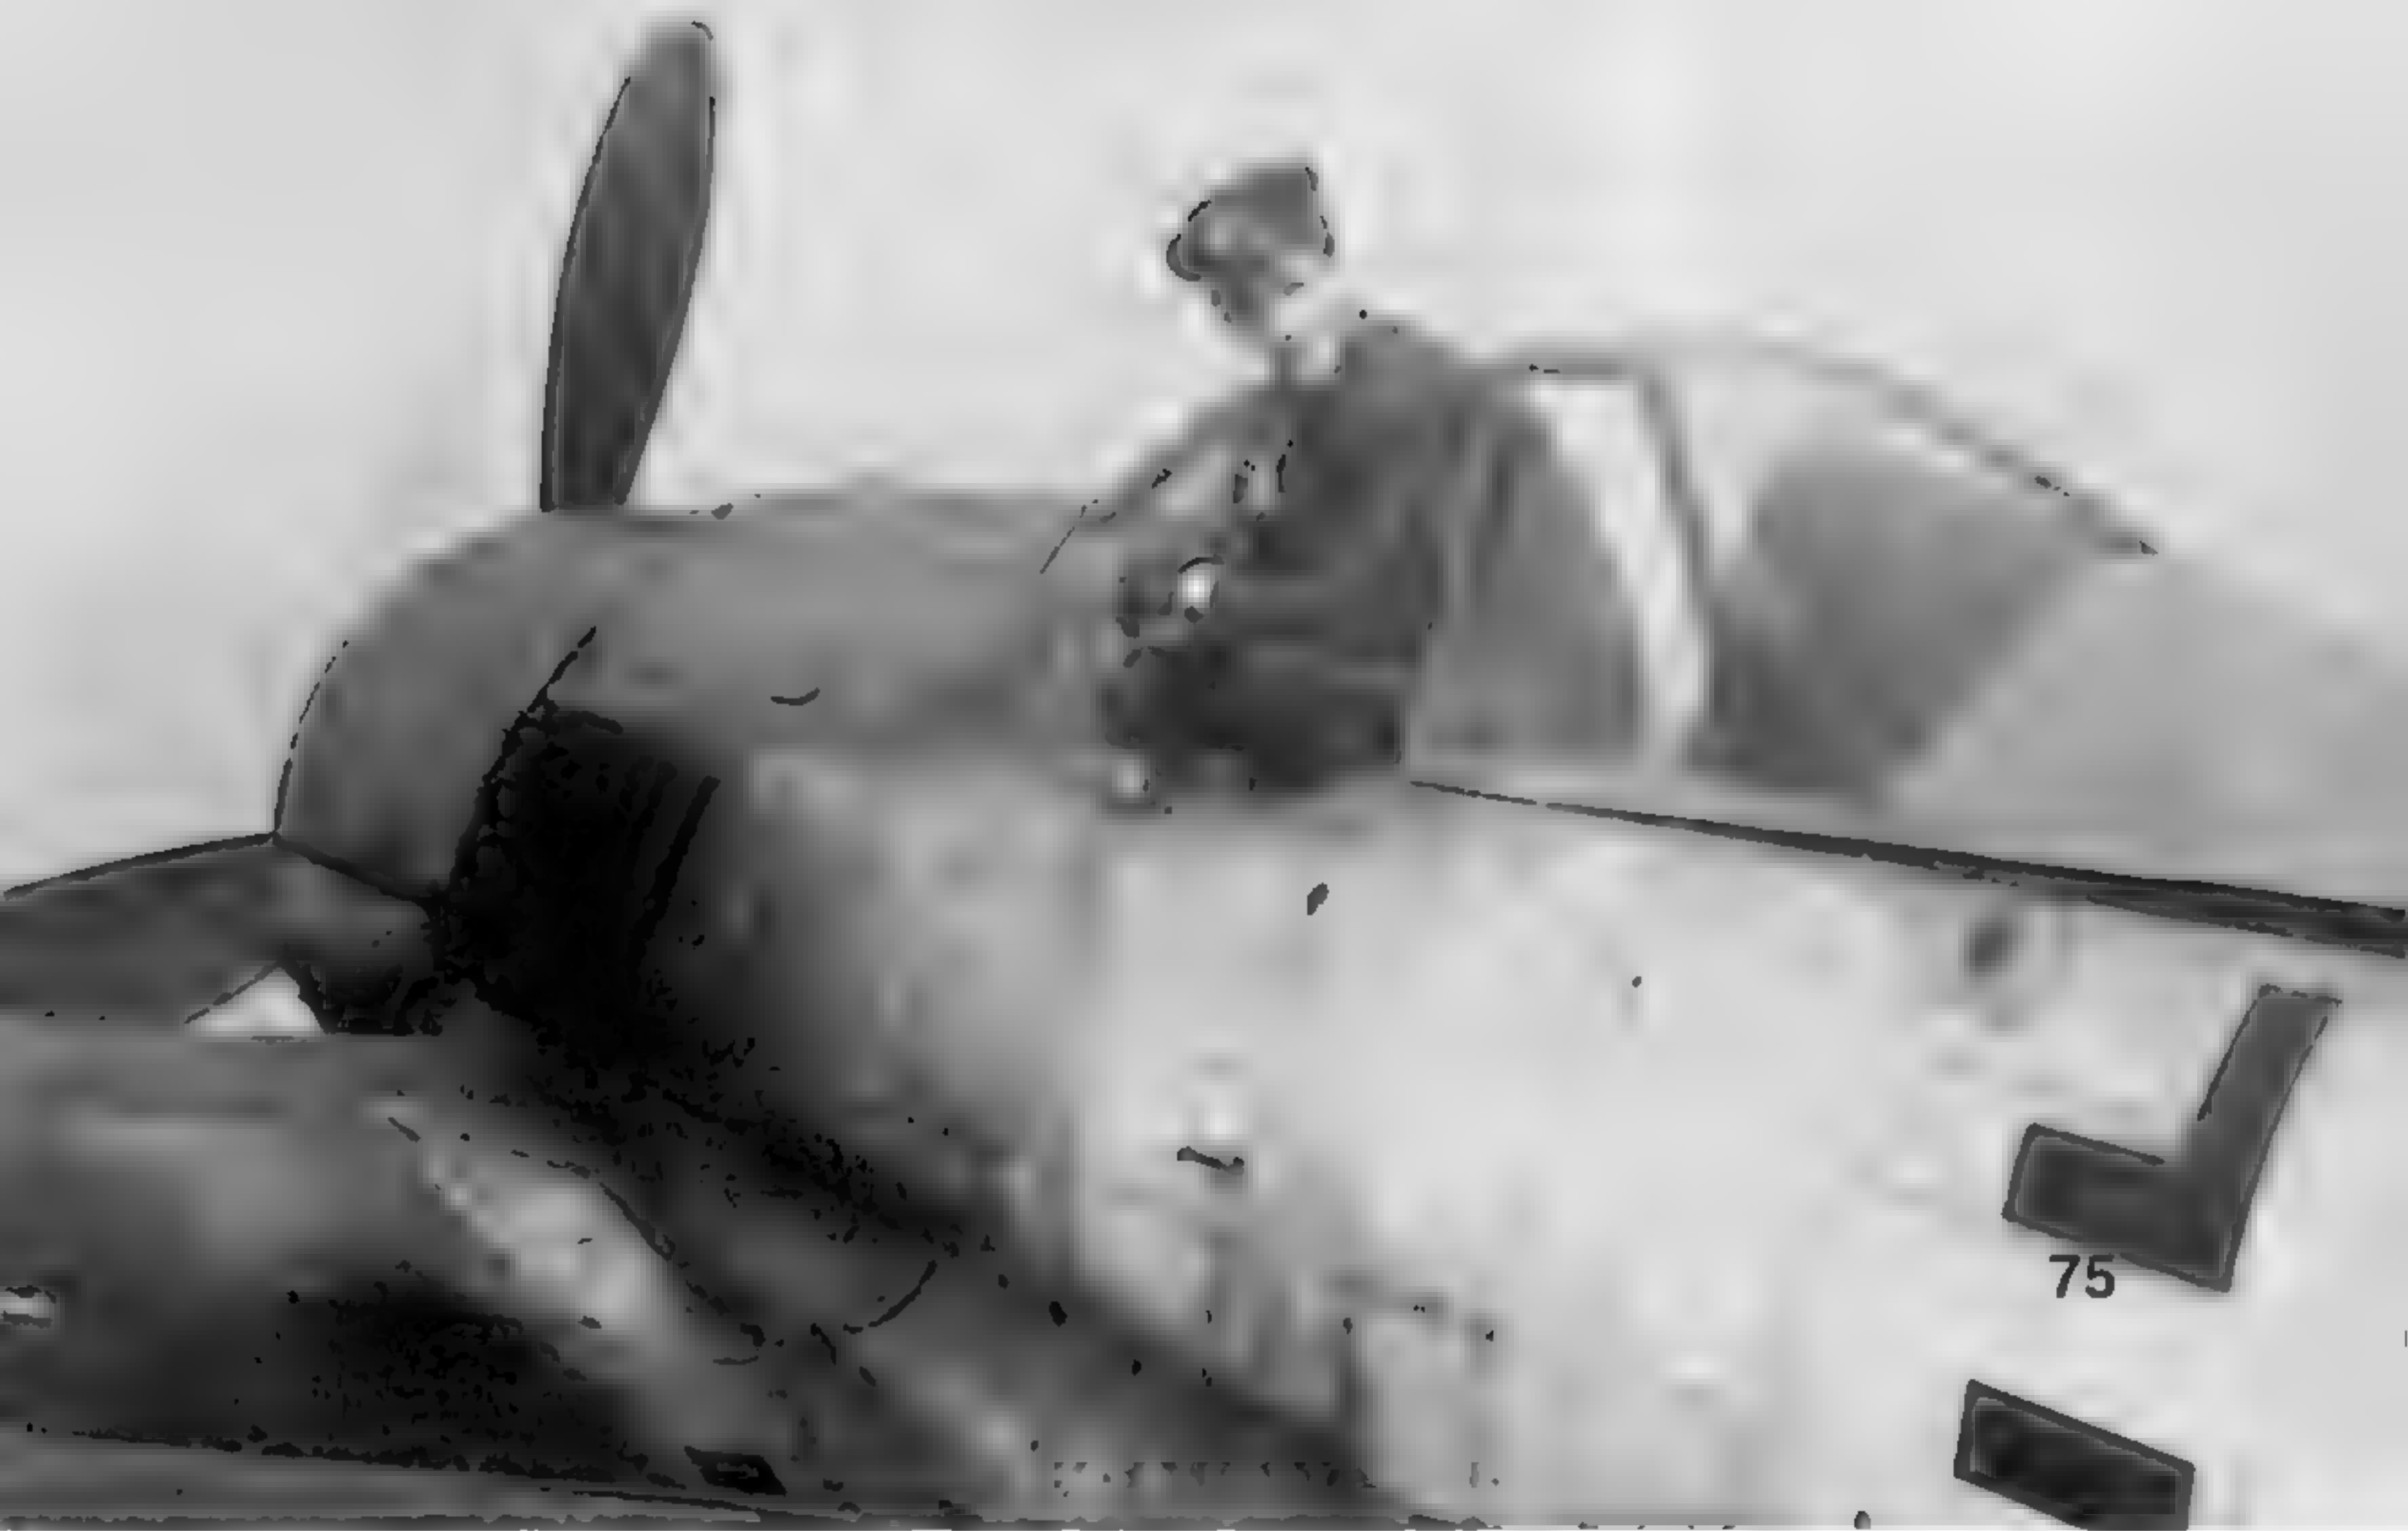
An RCAF officer perches on the cockpit sill of a captured Fw 190. This aircraft was equipped for night operations, which included the installation of flame dampers on each cylinder exhaust port. These dampers covered exhaust flames, preventing the aircraft's position from being given away and protecting the pilot's night vision. (Fochuk)

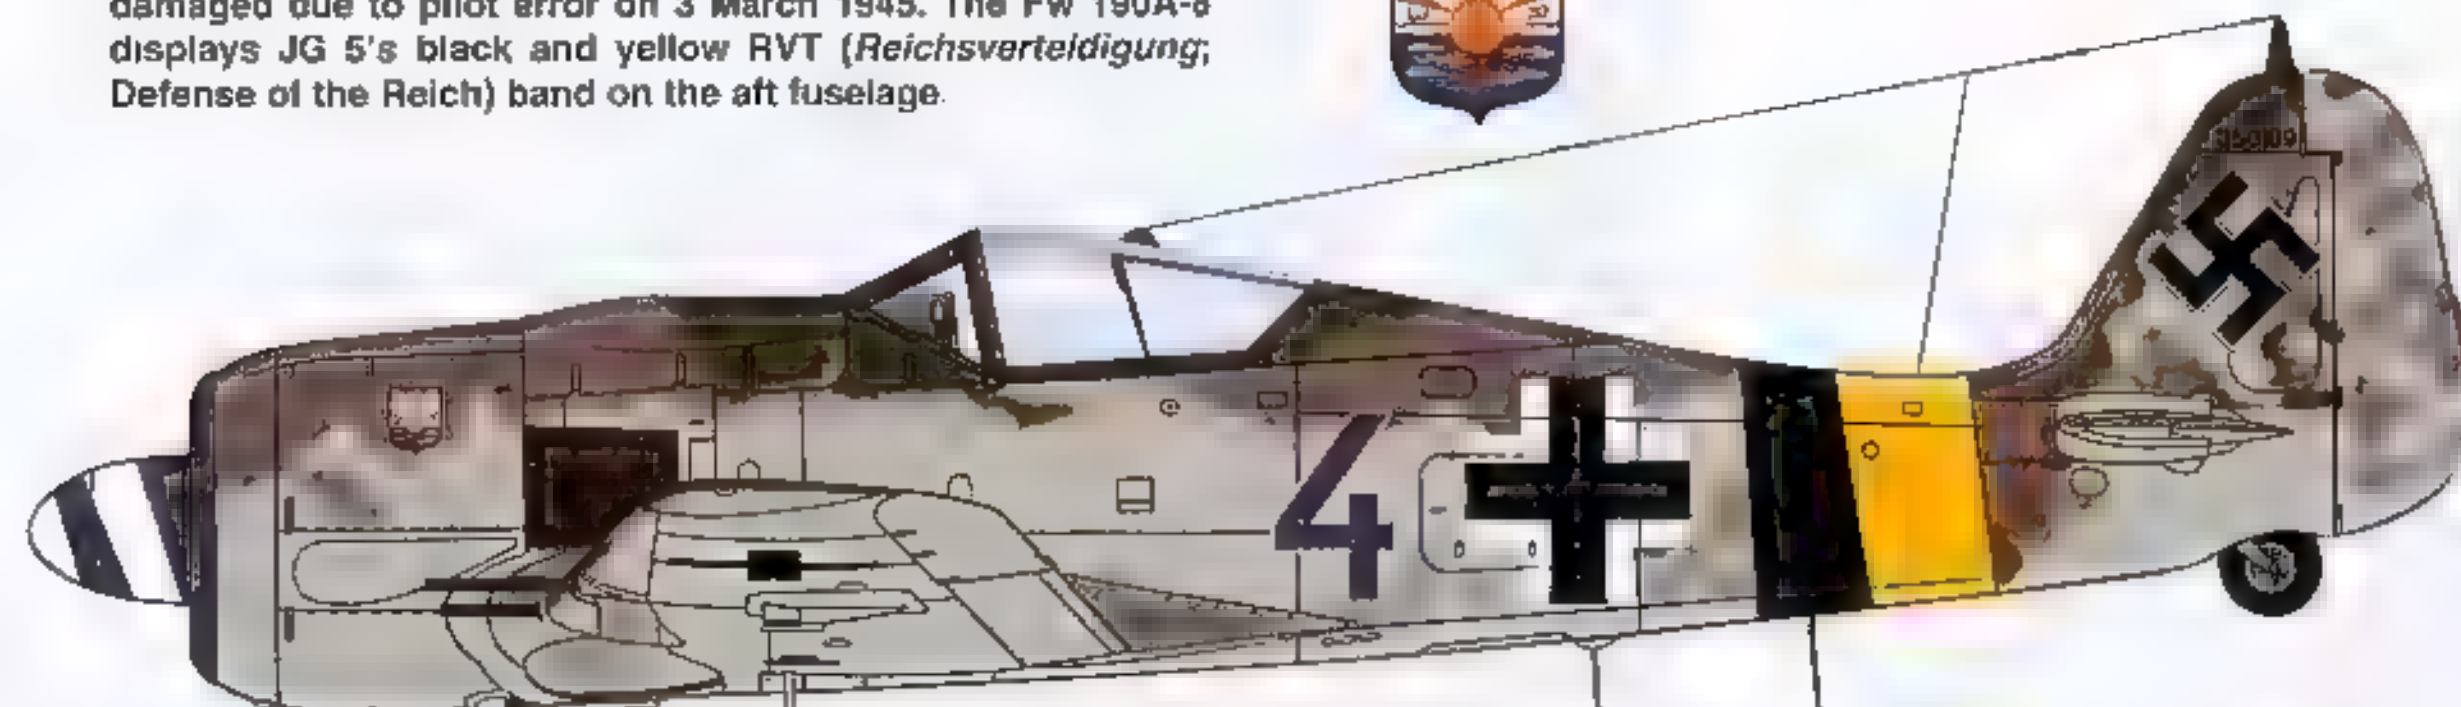
Fw 190A-8, Blue 4 (W.Nr. believed 350189) was assigned to 12.IV/JG 5 in the early spring of 1945. The aircraft was slightly damaged due to pilot error on 3 March 1945. The Fw 190A-8 displays JG 5's black and yellow RVT (*Reichsverteidigung*; Defense of the Reich) band on the aft fuselage.

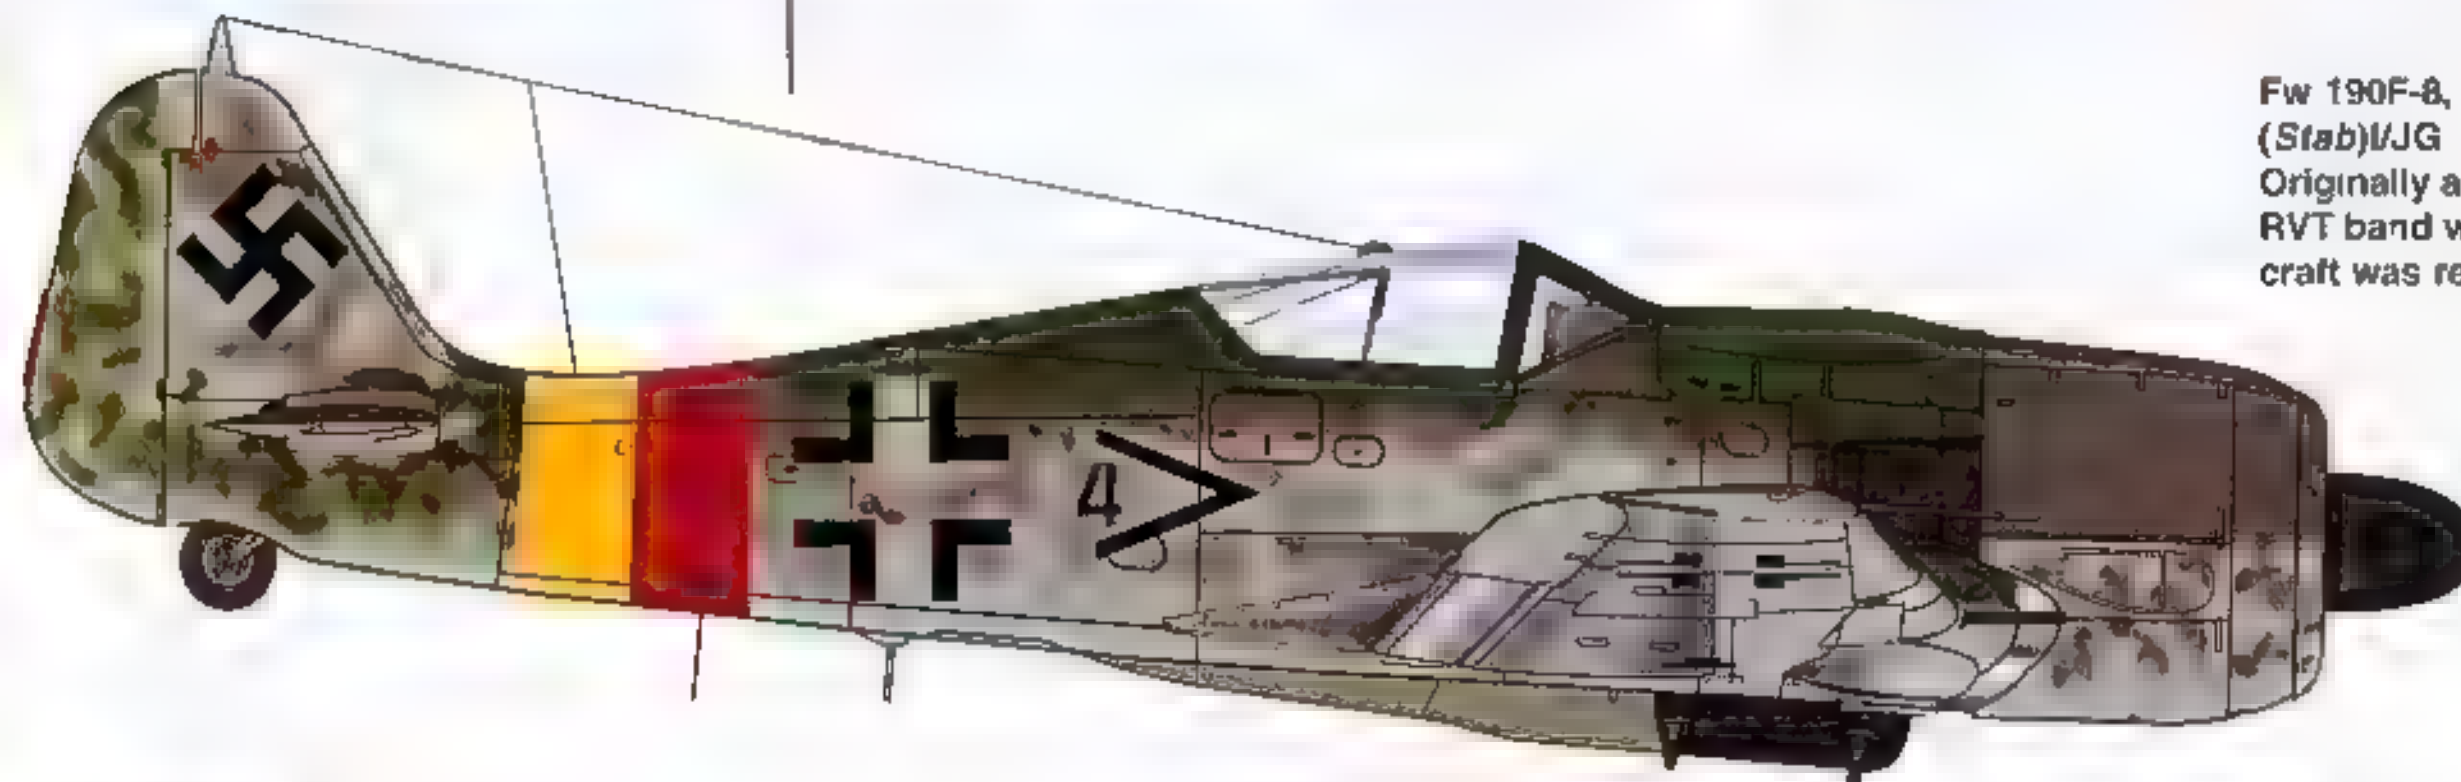
Fw 190F-8, Black Chevron 4 (W.Nr. 339786) was assigned to (Stab)/JG 301 in Germany during the spring of 1945. Originally assigned to JG 11, red segments of the aft fuselage RVT band were added to the yellow JG 11 band when this aircraft was reassigned to JG 301.

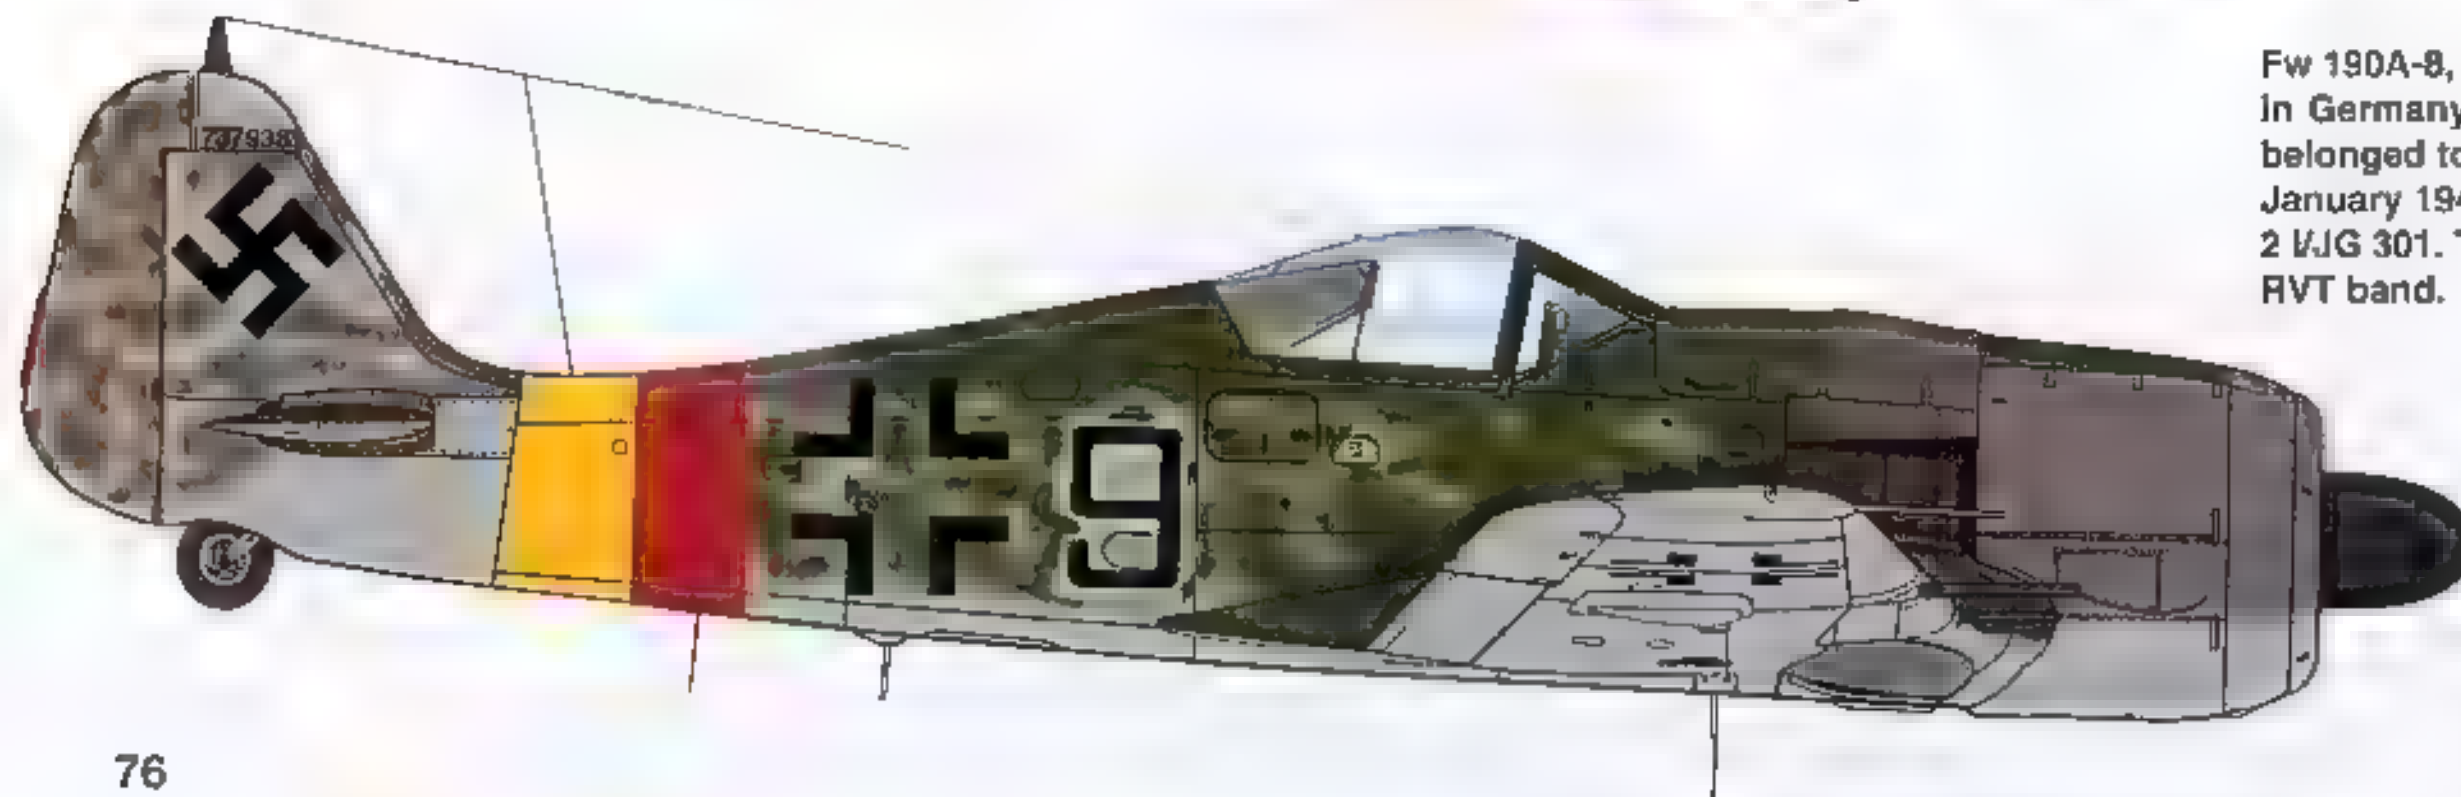
Fw 190A-8, Black 9 (W Nr. 737938) was operated by 2.I/JG 301 in Germany during the spring of 1945. The fighter originally belonged to II/JG 11; however, after damage sustained on 23 January 1945 was repaired, this Fw 190A-8 was reassigned to 2.I/JG 301. This resulted in the reverse application of JG 301's RVT band.

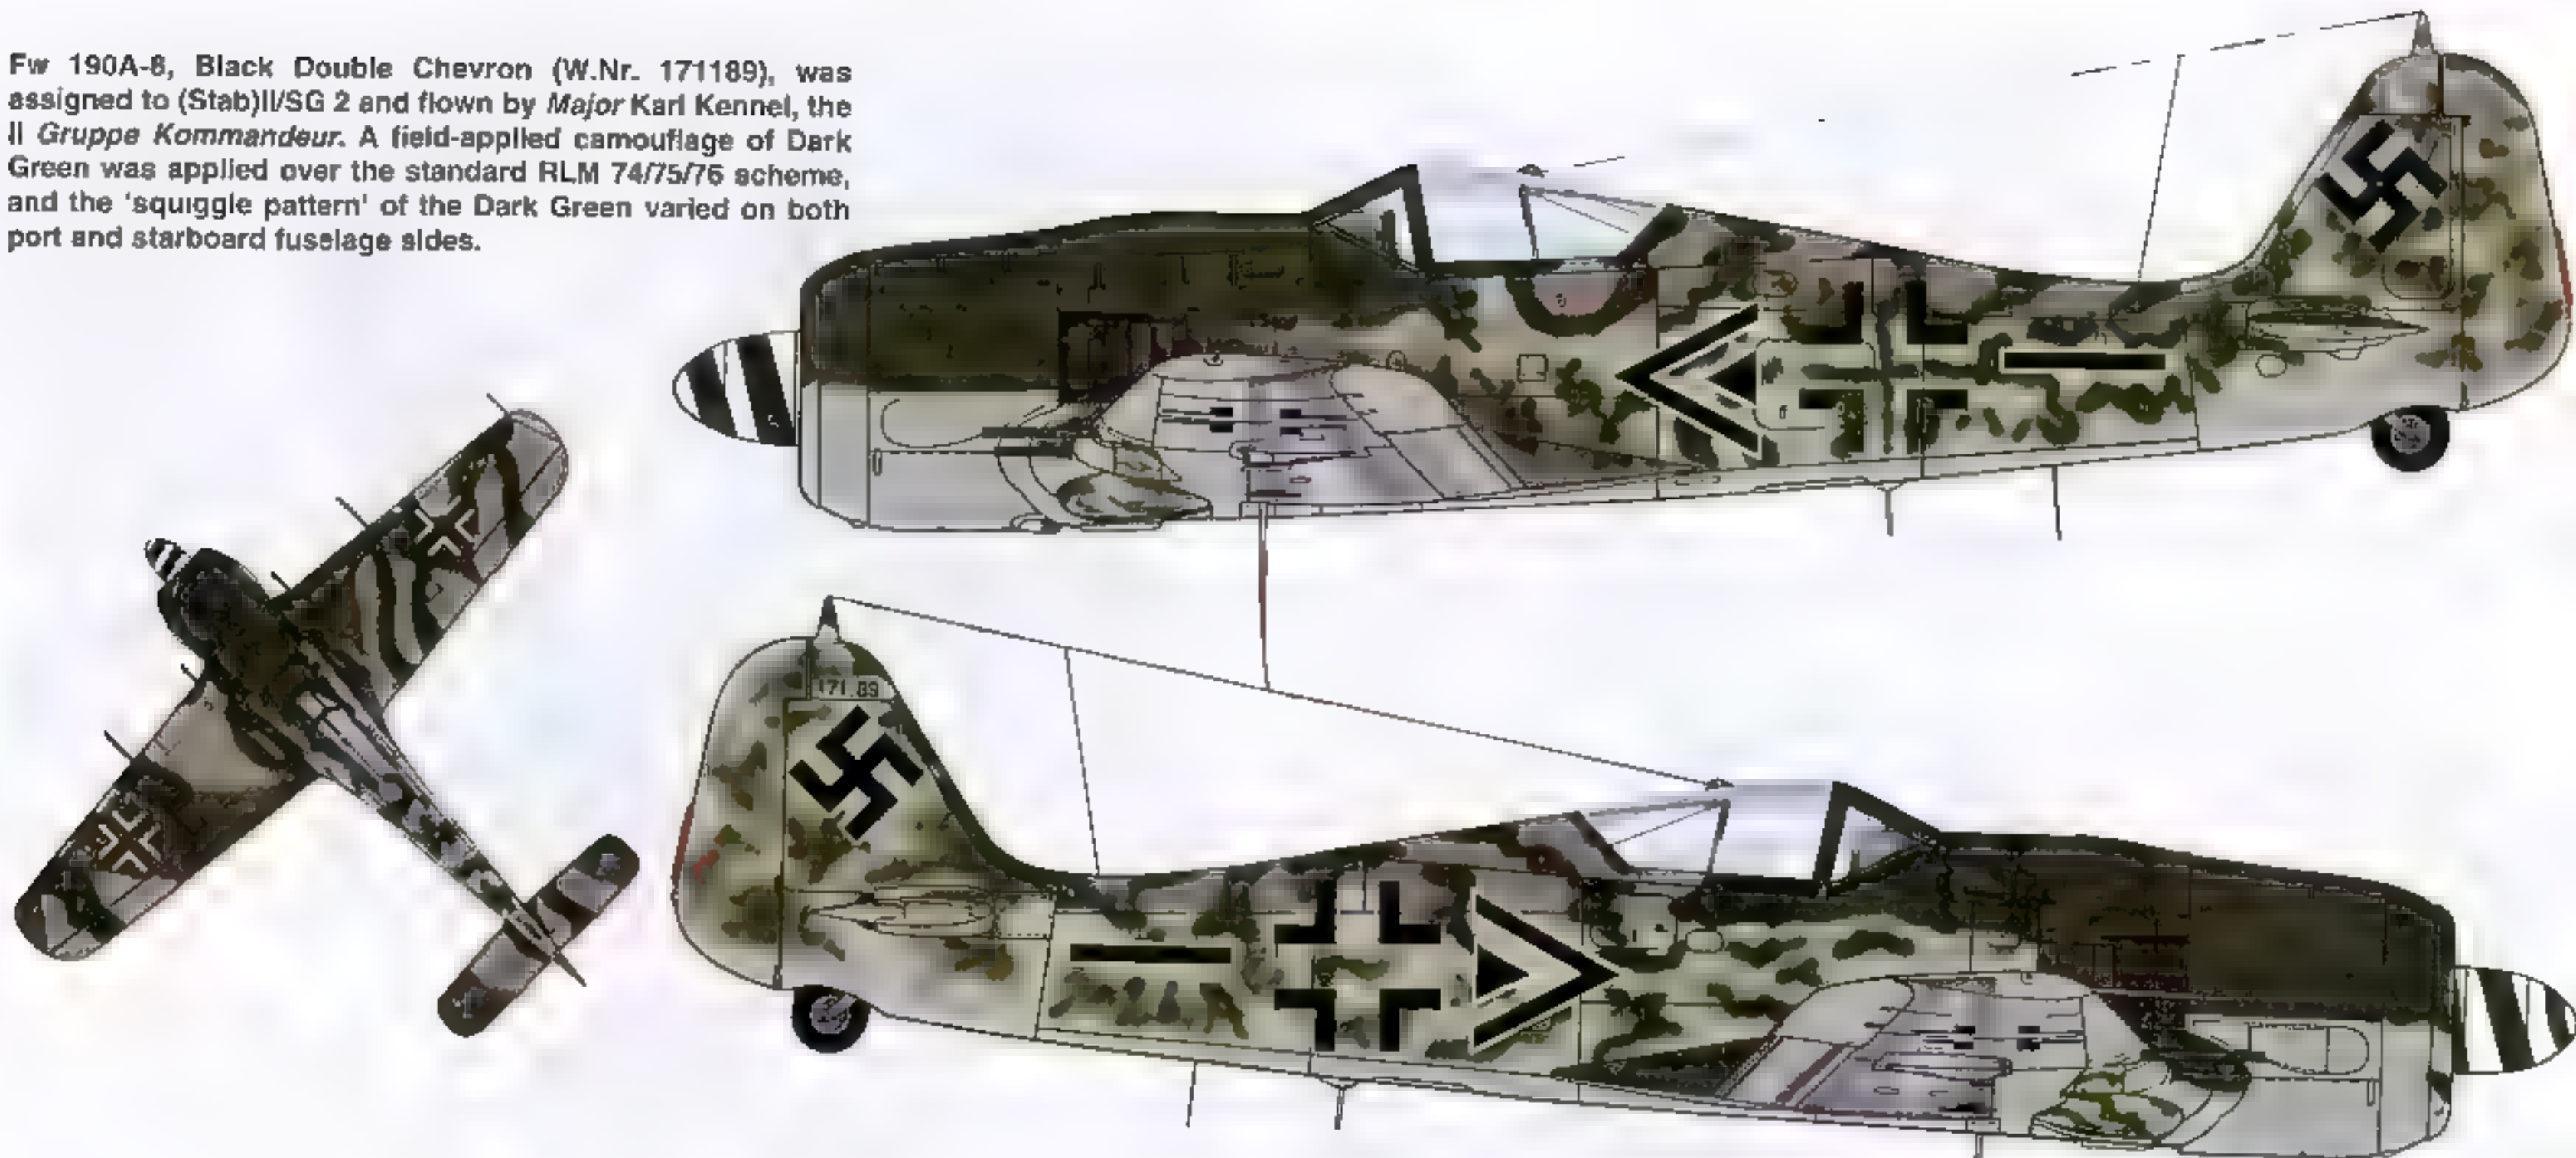
Fw 190A-8, Black Double Chevron (W.Nr. 171189), was assigned to (Stab)II/SG 2 and flown by *Major* Karl Kennel, the II Gruppe Kommandeur. A field-applied camouflage of Dark Green was applied over the standard RLM 74/75/76 scheme, and the 'squiggle pattern' of the Dark Green varied on both port and starboard fuselage sides.

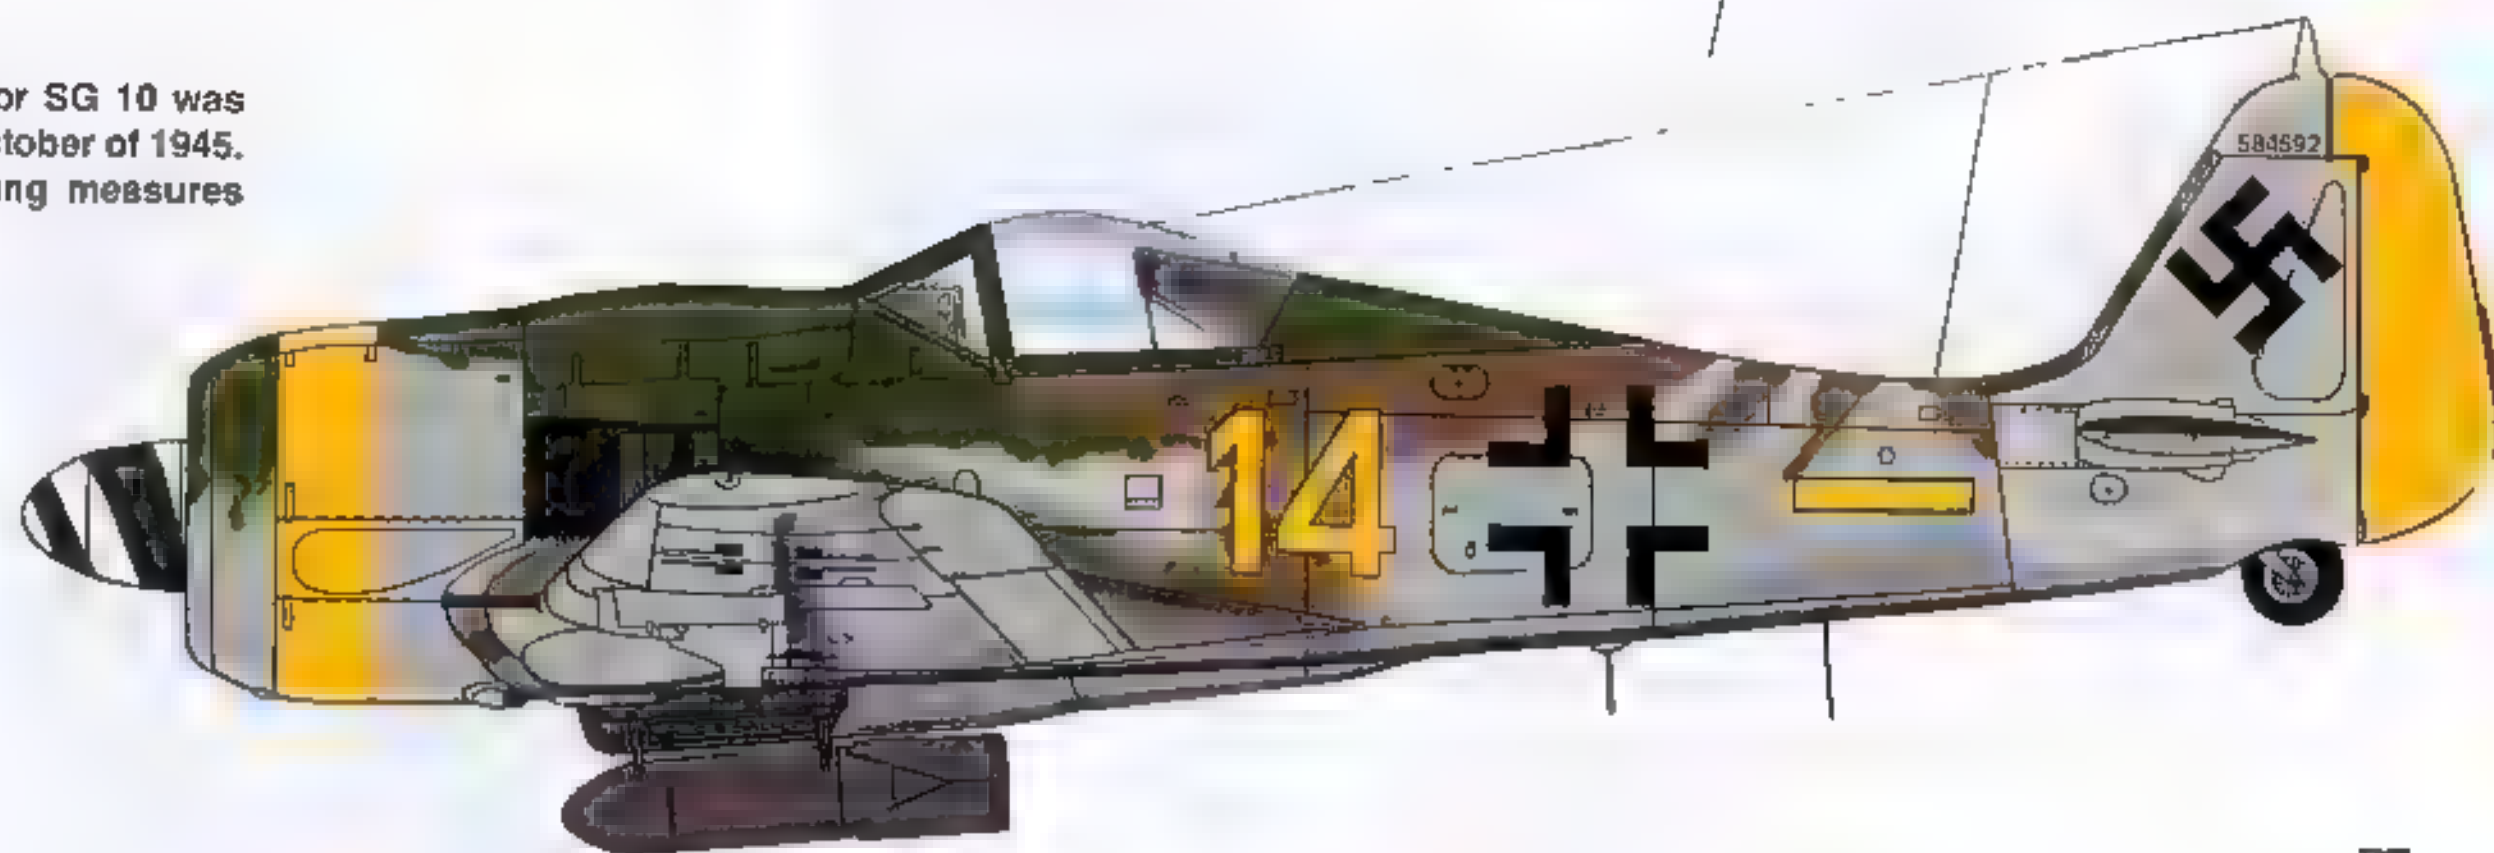
Fw 190F-8, Yellow 14 (W.Nr. 584592) of SG 2 or SG 10 was consigned to the scrap heap in September or October of 1945. Dispersed subassembly work and weight saving measures resulted in variations in component colors.

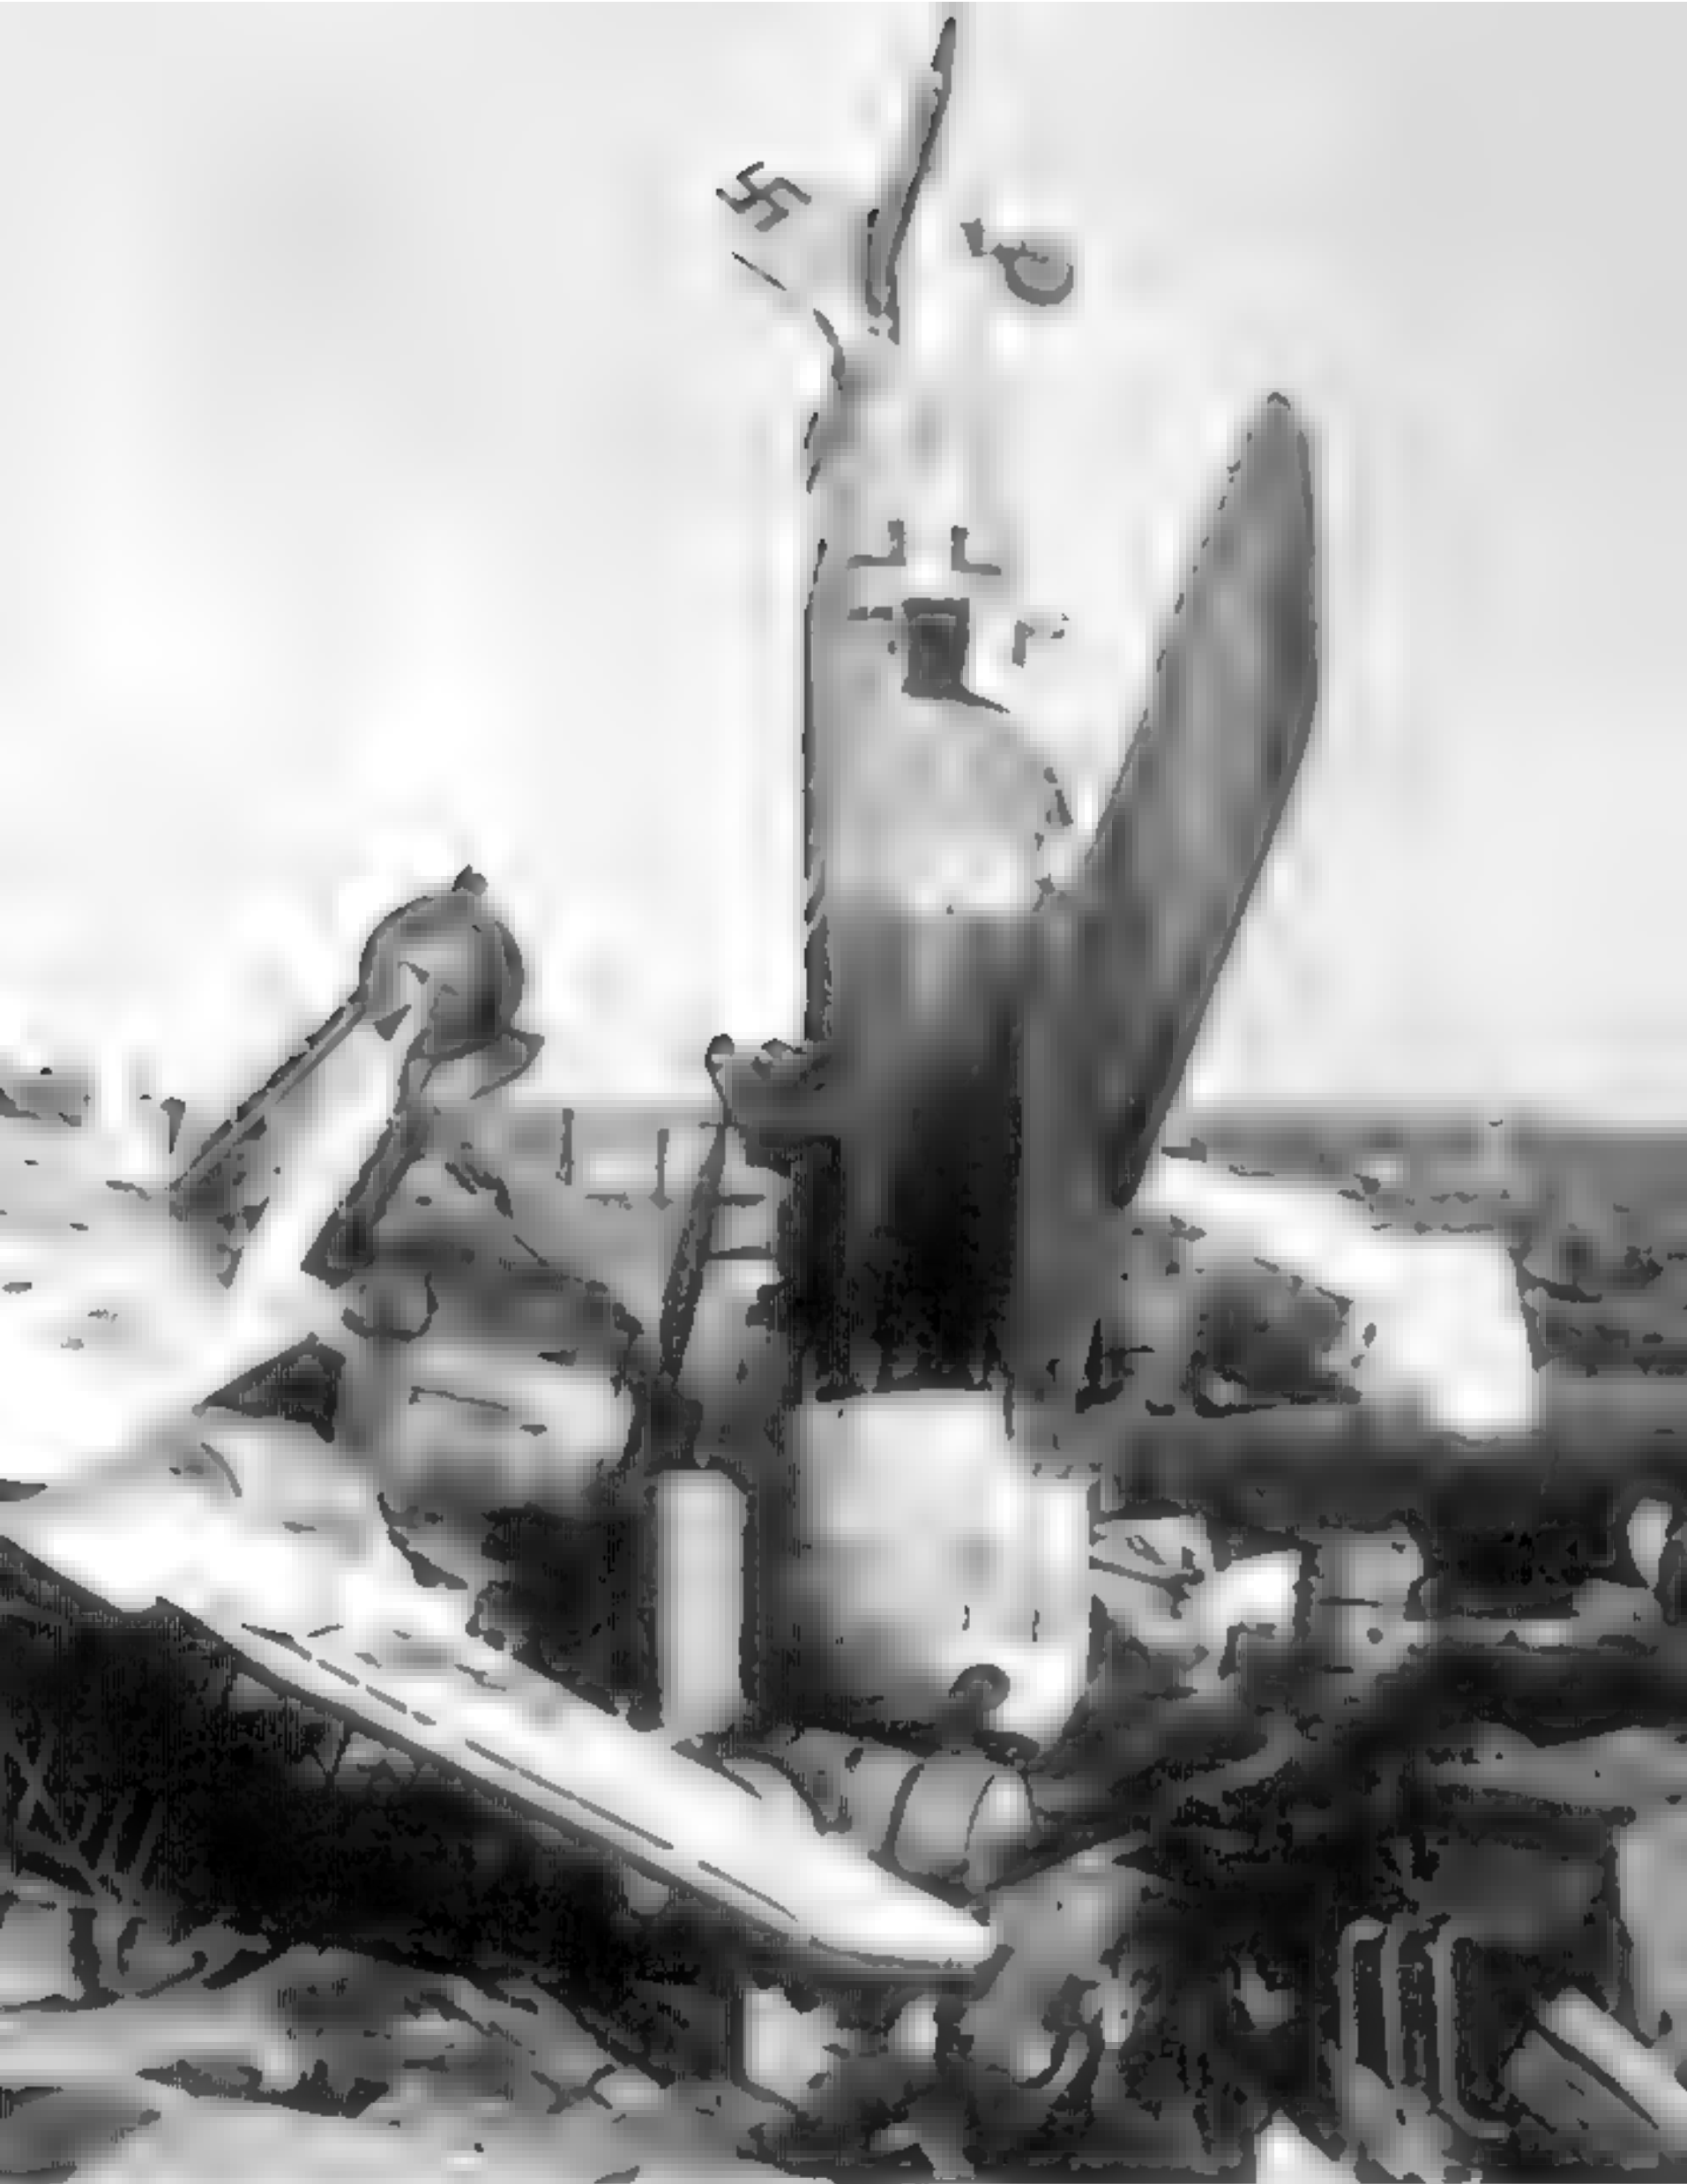
Fw 190F-8, Yellow 14, (W Nr. 584592) stands on its nose in the scrap pile at Neubiberg, Germany in the fall of 1945. This late-war production aircraft was missing its canopy and rudder, while the fuselage access panel was partially removed. Aircraft subassemblies were painted with several shades of paint, due to the dispersed manufacture of these components. (Crow)

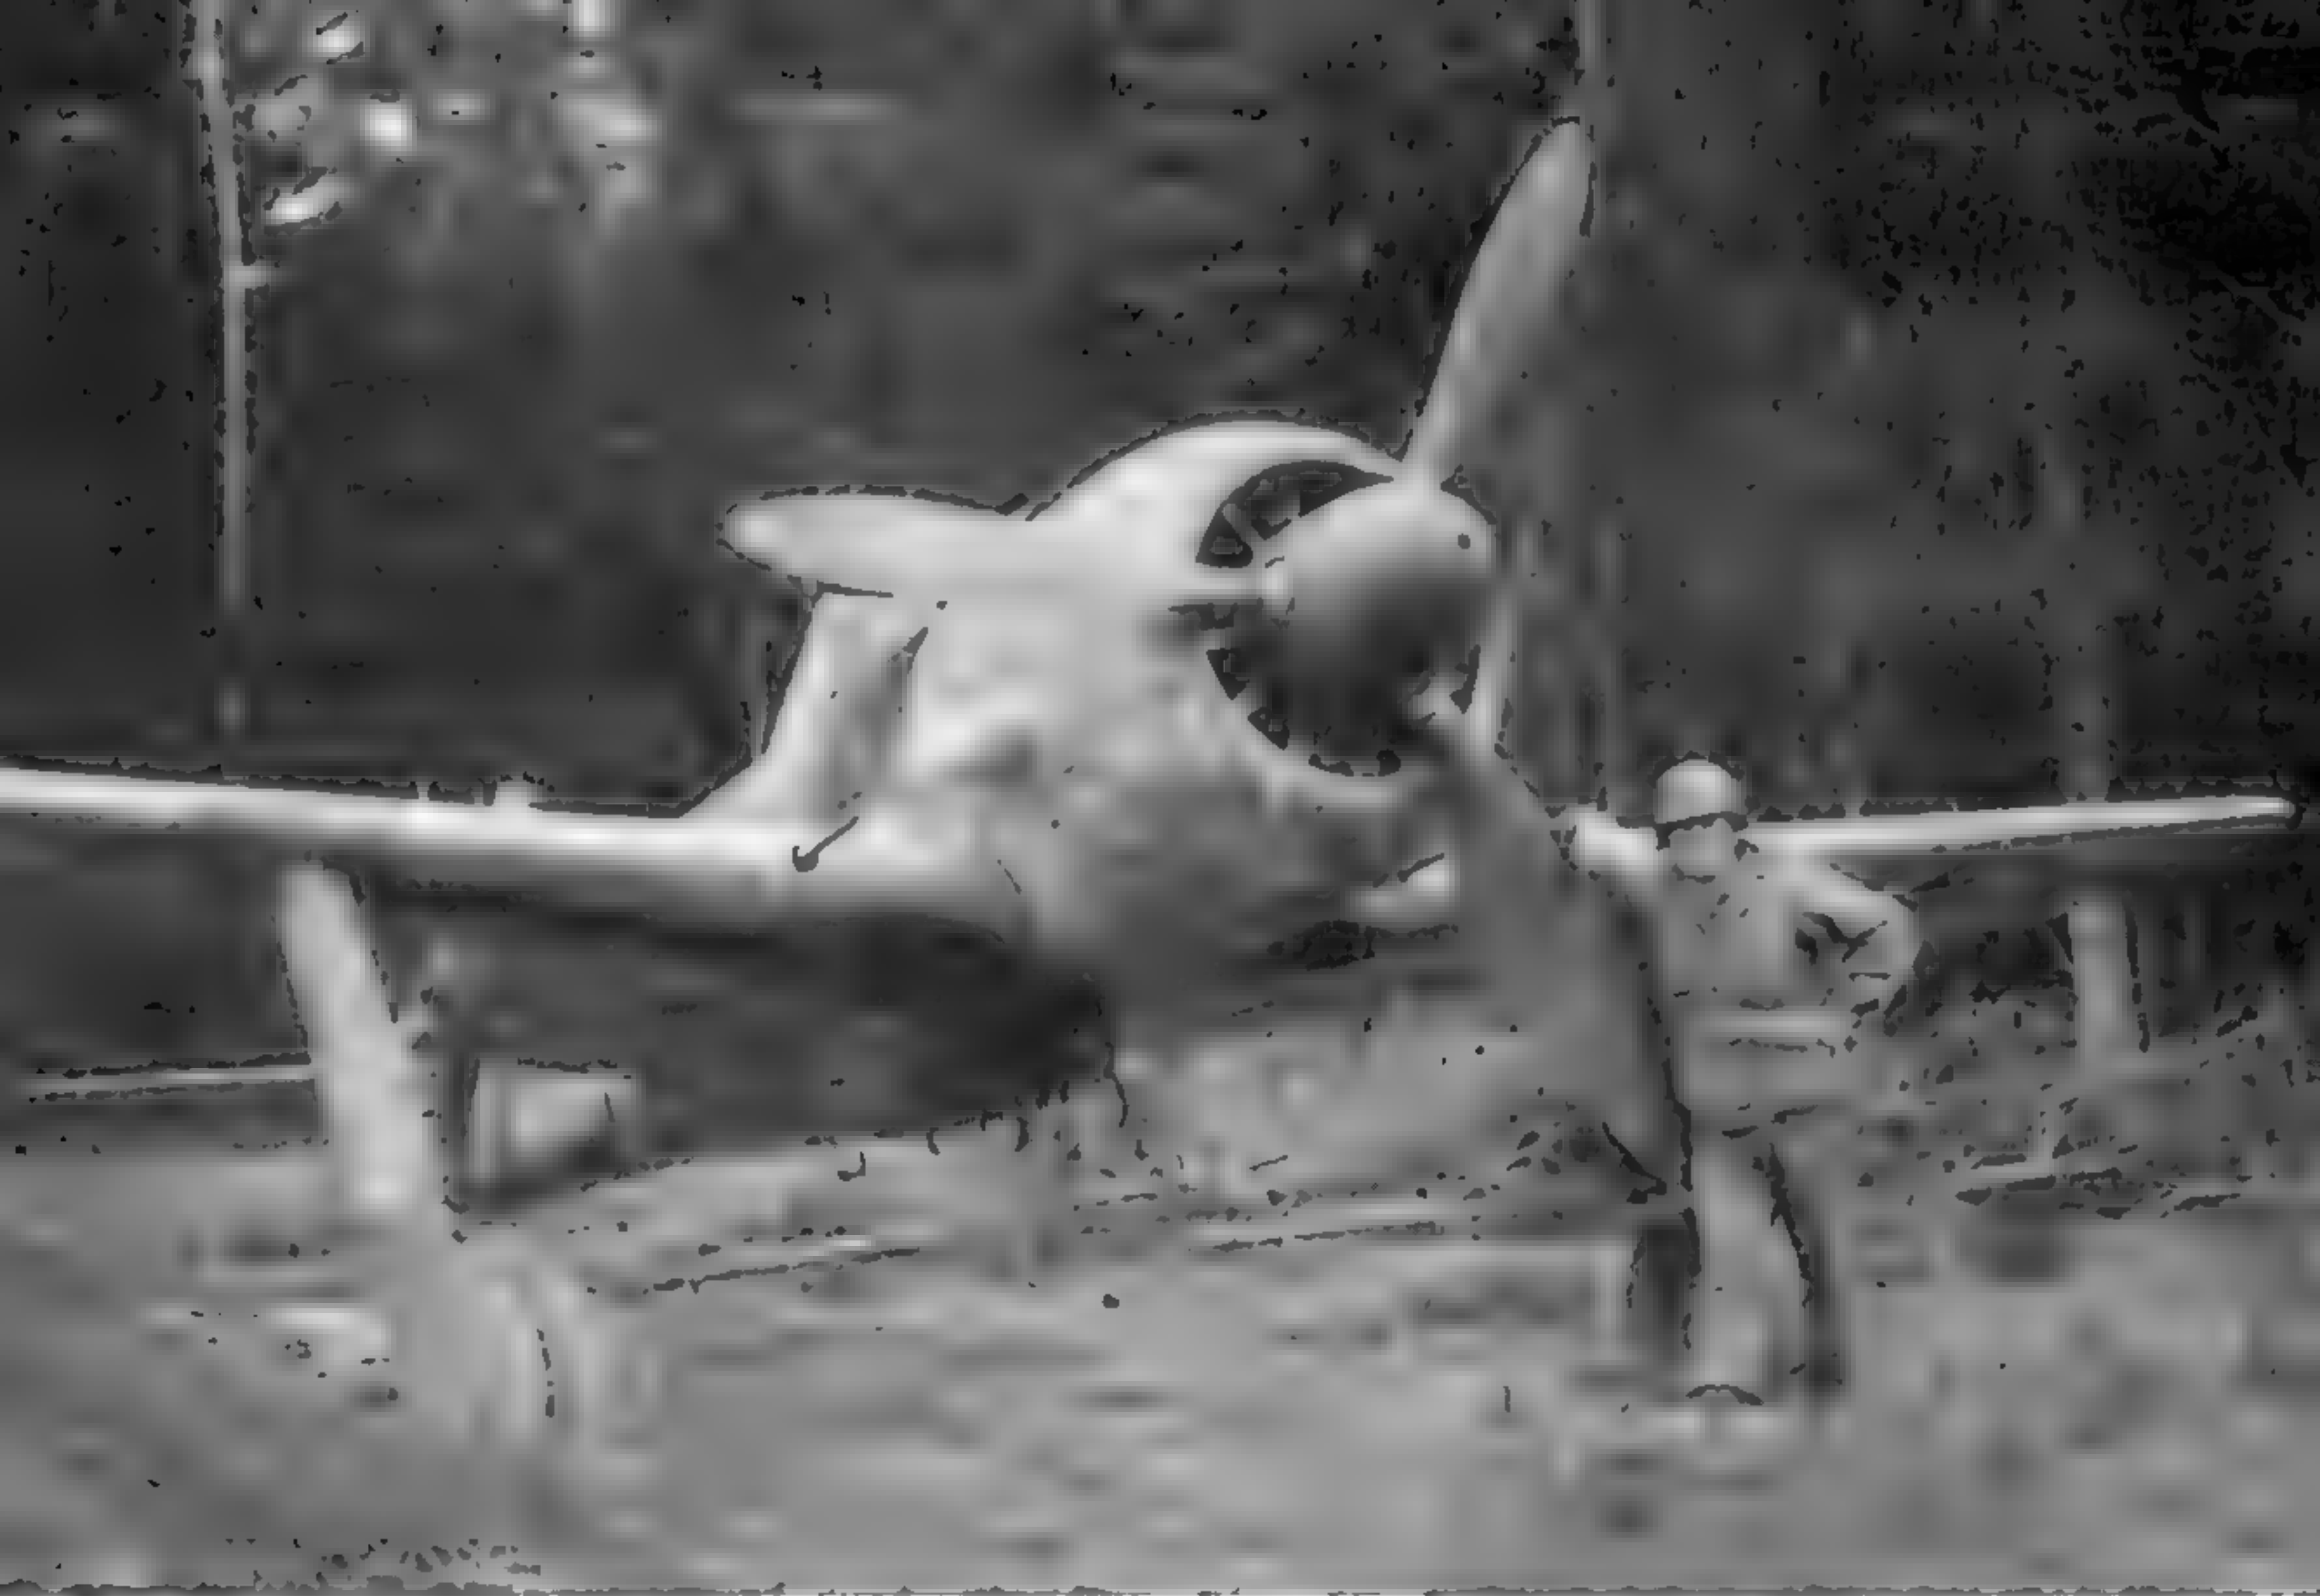
**A US soldier leans on the propeller blade of an Fw 190A in Germany during the spring of 1945. A number (339786) has been painted on the lower engine cowl lip. The outboard 20mm cannons were removed from this Fw 190A to reduce weight. (Crow)**
